ENGINEERING ANALYSIS
OF THE
RUSSIAN T34/85 TANK

SEPTEMBER, 1951

CIA Information Report
Number 00-T-00061

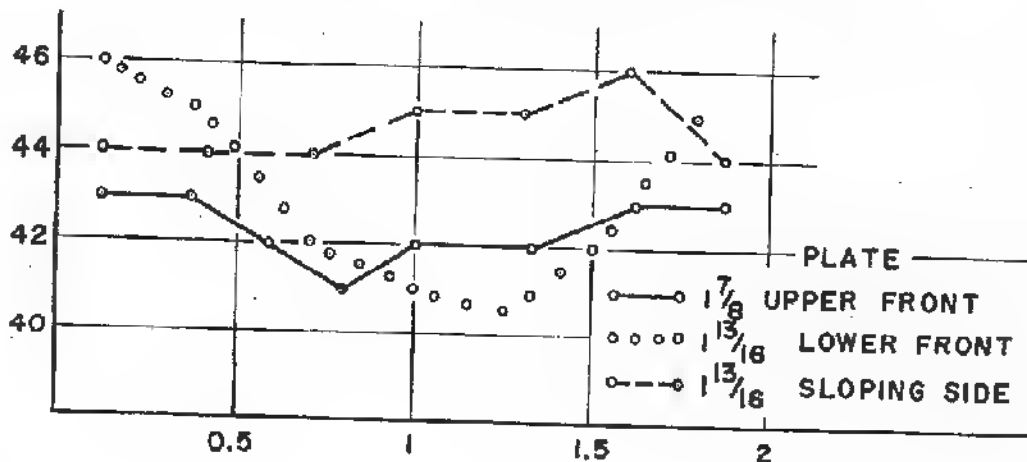
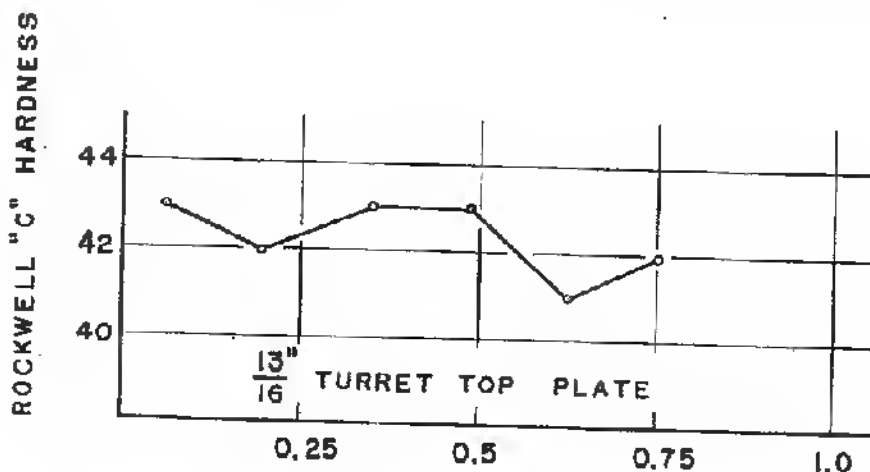
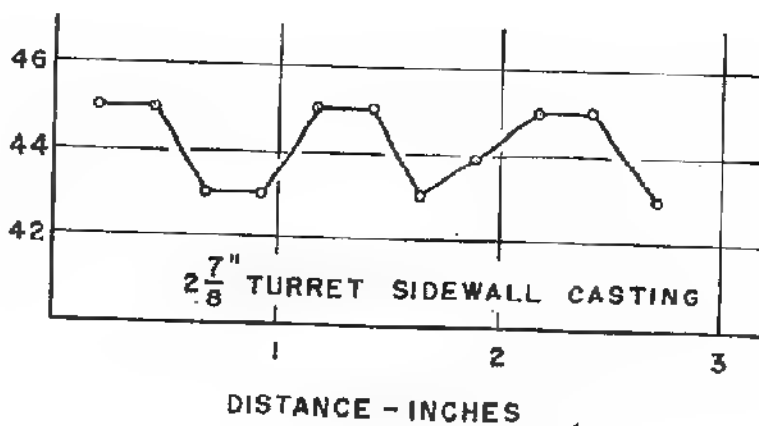
Figure 4

<u>Armor Section</u>	<u>Thickness Inches</u>	<u>Hardness Range thru Brinell</u>	<u>Cross Section Rockwell "C"</u>
Turret Top Plate	13/16	418	41-43
Turret Sidewall Casting	2-7/8	448	43-45
Hull - Roof Plate	13/16	207	12-13
Sloping Front Plate-Upper	1-7/8	418	41-43
Sloping Front Plate-Lower	1-13/16	387-418	41-46
Sloping Side Plate	1-13/16	444	44-46

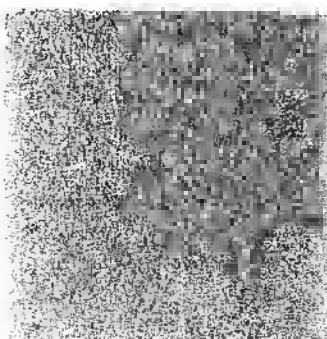
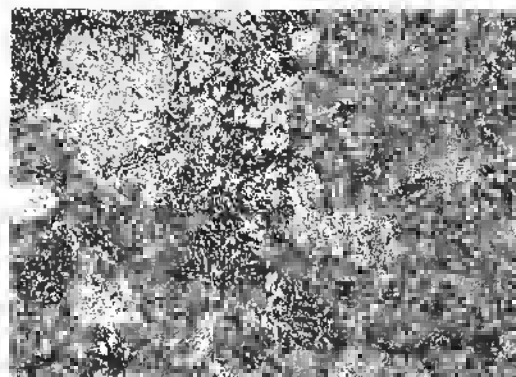
1-13/16" LOWER SLOPING FRONT PLATE (ROLLED HOMOGENEOUS ARMOR)

A moderately clean armor with typical inclusions shown in the unetched photomicrograph. The surface was mostly martensitic with increasing amounts of ferrite and transformation products toward the center. Material probably did not receive a good quench. Possibly tempered at a low temperature. Rolled only in one direction.

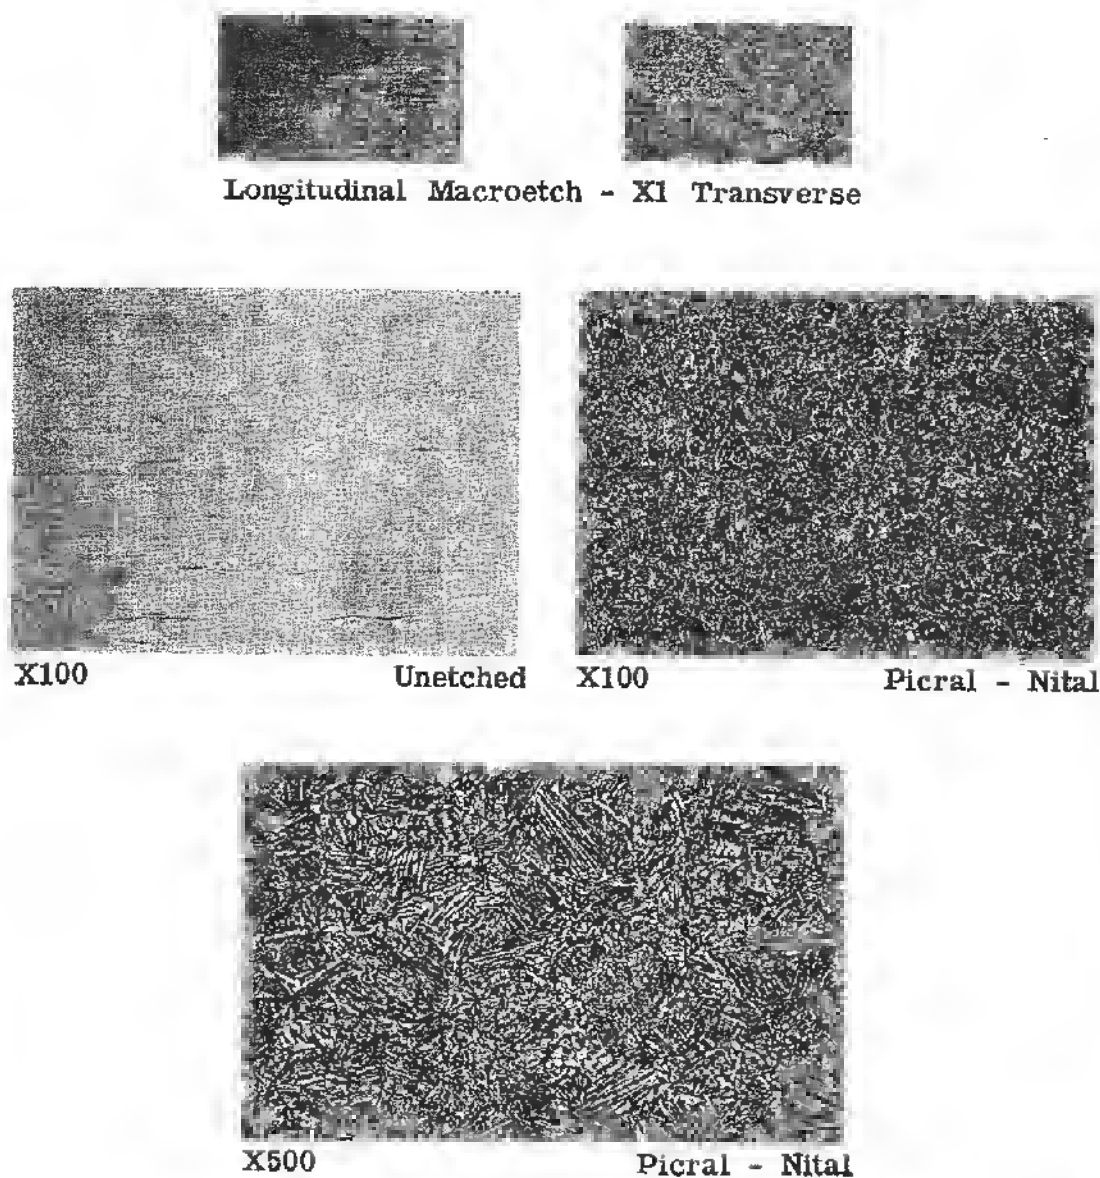
Figure 9

This material was not quite as clean as the other rolled armor. Typical inclusions are shown in the photomicrograph. The structure at the surface and center were about the same, martensite, ferrite, and some transformation products. Material possibly had a low temper. Armor was cross rolled.

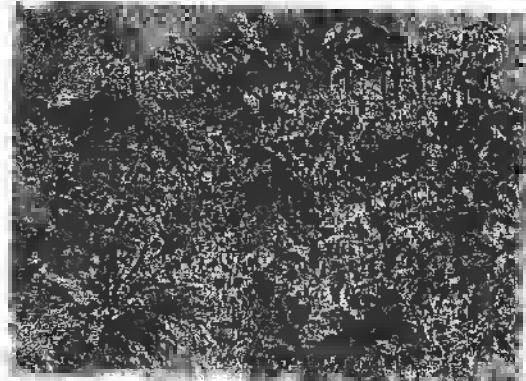
2-7/8" TURRET SIDEWALL (CAST HOMOGENEOUS ARMOR)

The strength and ductility of the rolled plate are satisfactory for the hardness and the transverse properties are only slightly below the longitudinal values. Due to casting defects and unsound metal, the side wall showed an absence of ductility and the strength was less than that expected for the hardness.

The cast armor had small globular inclusions well dispersed through the matrix. The concentration was not heavy except in a few areas. A very large silicate inclusion was found in the sample examined and is shown in the photomicrograph. The surface was all martensite with transformation products being found near the core. Material possibly had a low temper.

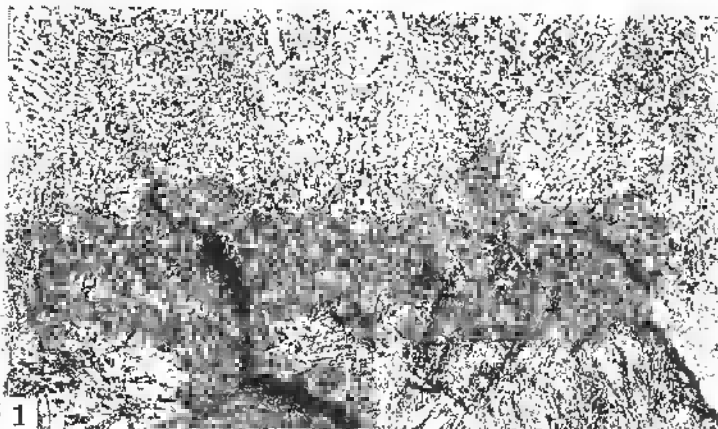
Photomicrographs 1 and 2 were taken of weld A which was also the typical structure of welds B and D. The weld metal structure consists of scattered pearlite and small carbides in a dendritic ferrite matrix. Photomicrograph 1 shows cracks formed between the weld and base metals, while photomicrograph 2 illustrates a perfectly sound weld. Weld C is austenitic with good fusion as shown in photomicrograph 3.

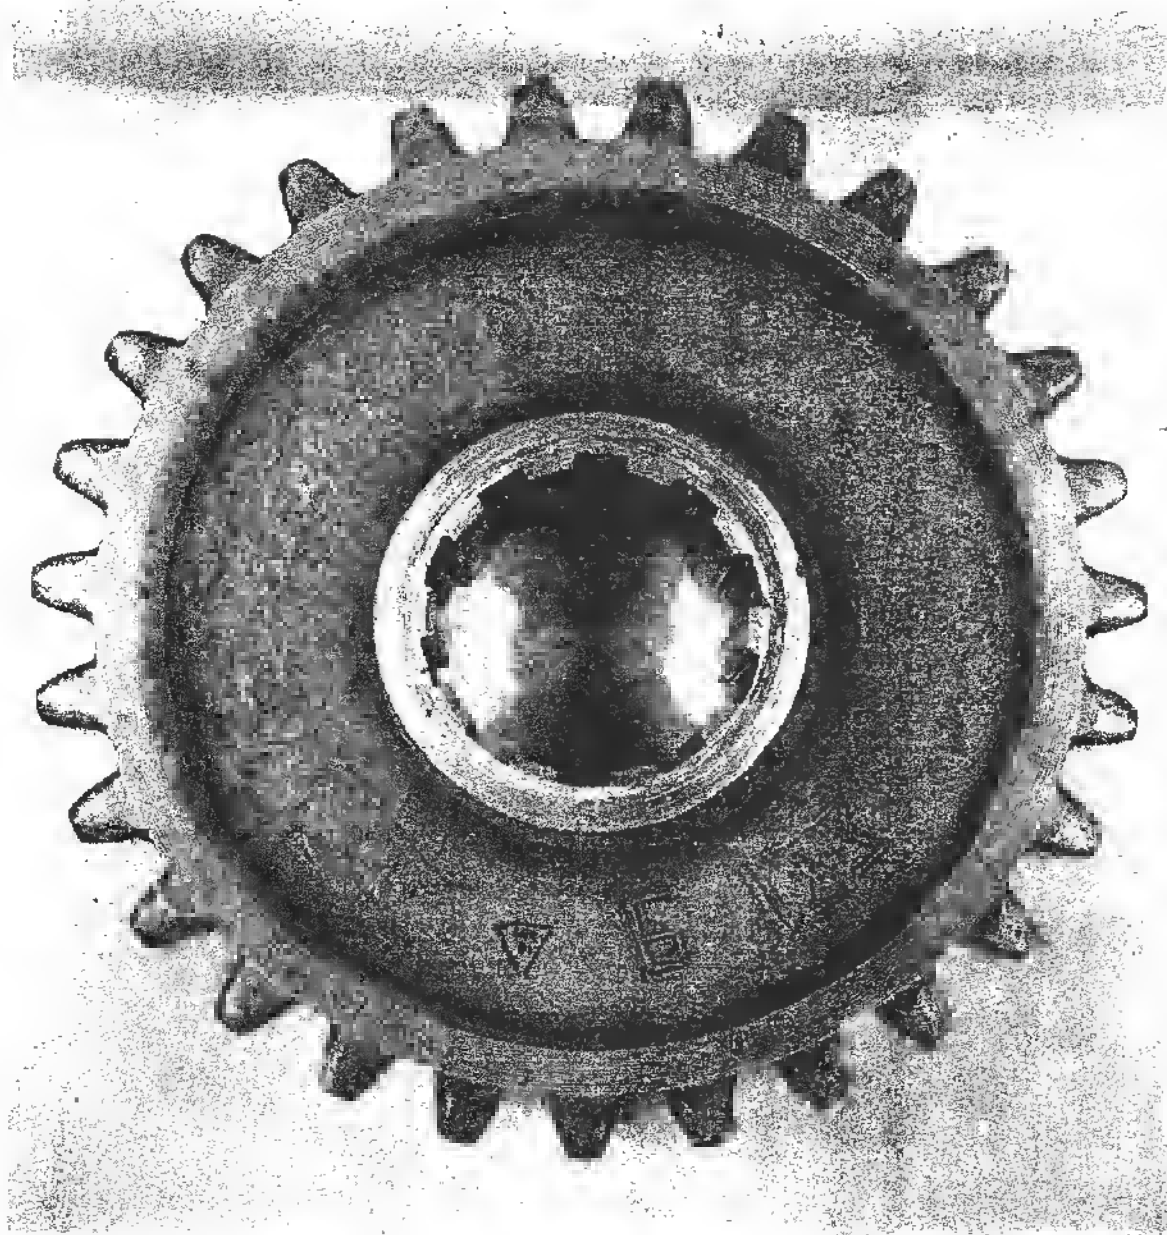
0702.3.2 - SECOND SPEED DRIVEN GEAR

The second speed gear was forged, machined, carburized all over and hardened except for the bore. The gear was then shot blasted and the top of the splines on the inside of the hub rough ground. The chamfered ends of the teeth were battered. Grooves were worn on both sides of the teeth at the bottom. Photograph 0702.3.2

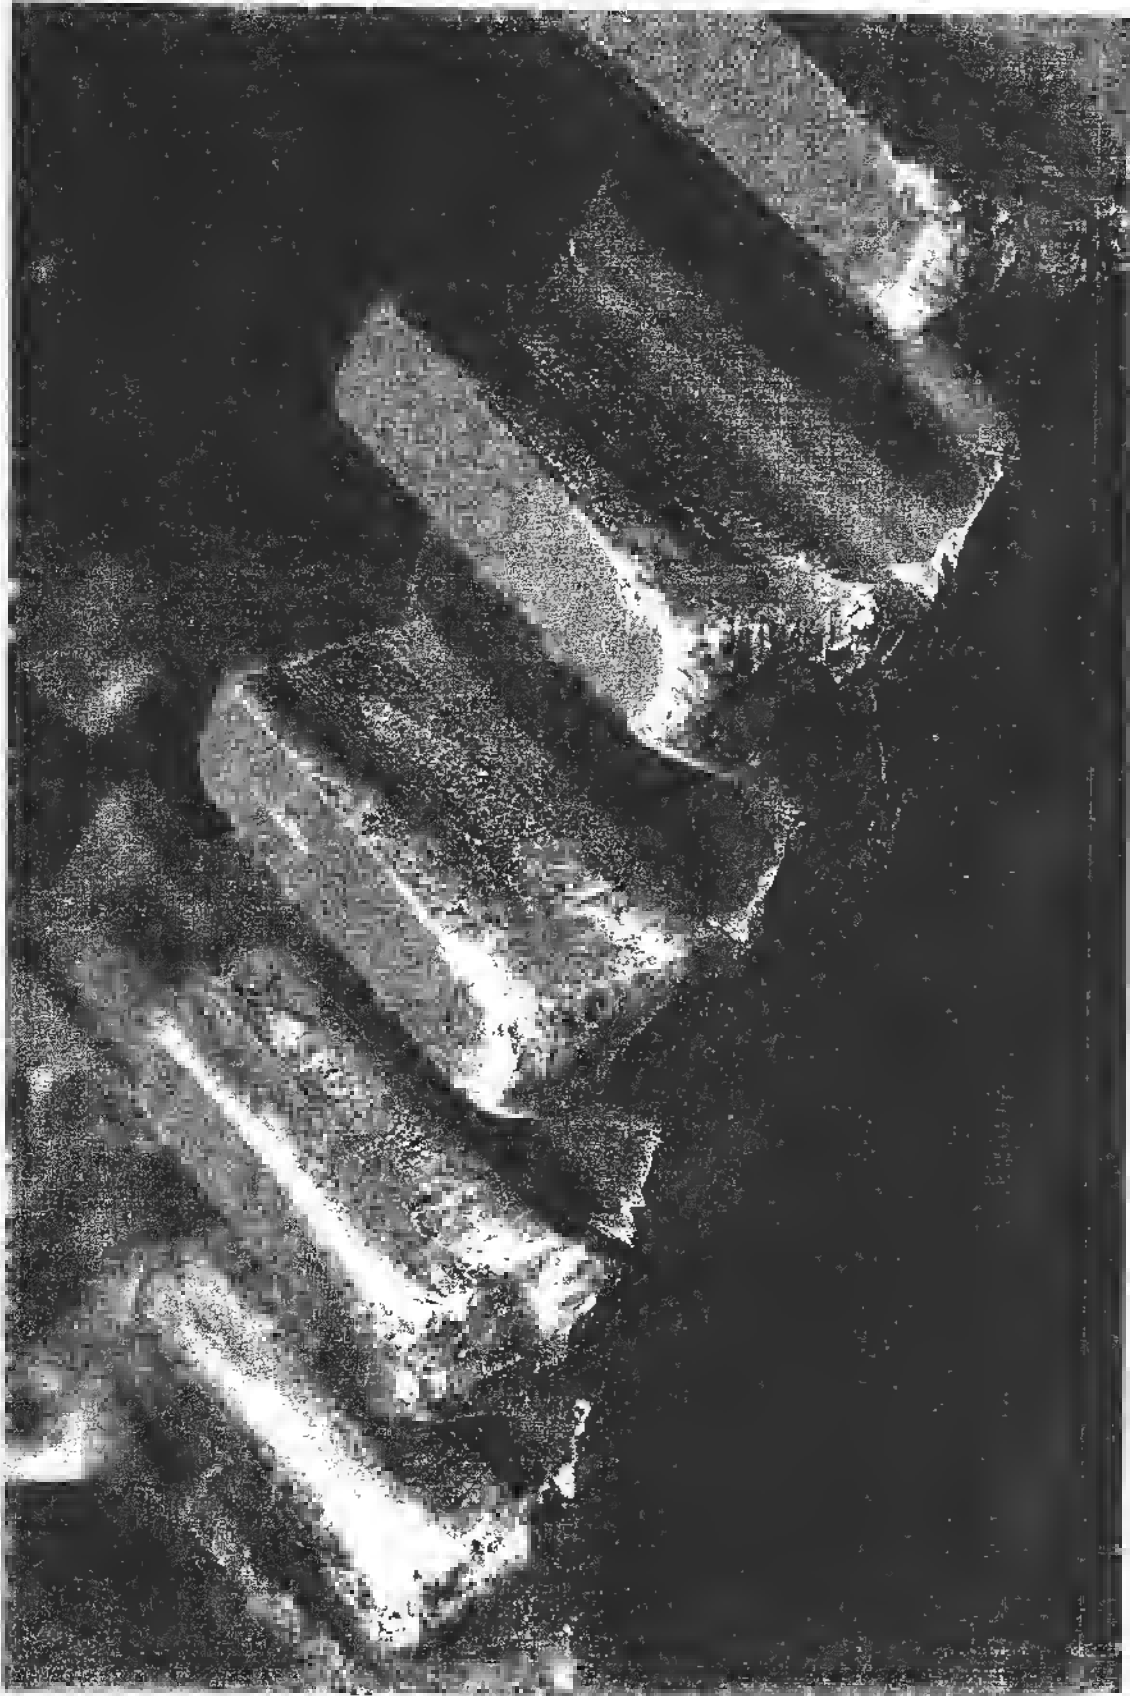
0702.2.1 a - FIRST SPEED DRIVEN GEAR

The first speed gear was forged, machined, carburized all over and hardened except for the bore. The gear was then shot blasted and the top of the splines on the inside of the hub rough ground. The ends of the hub were faced. Both engaging ends of the teeth were battered and chipped. There appeared to be inadequate chamfer. The teeth were heavily worn on opposite ends on both sides. Photograph 0702.3.1 a

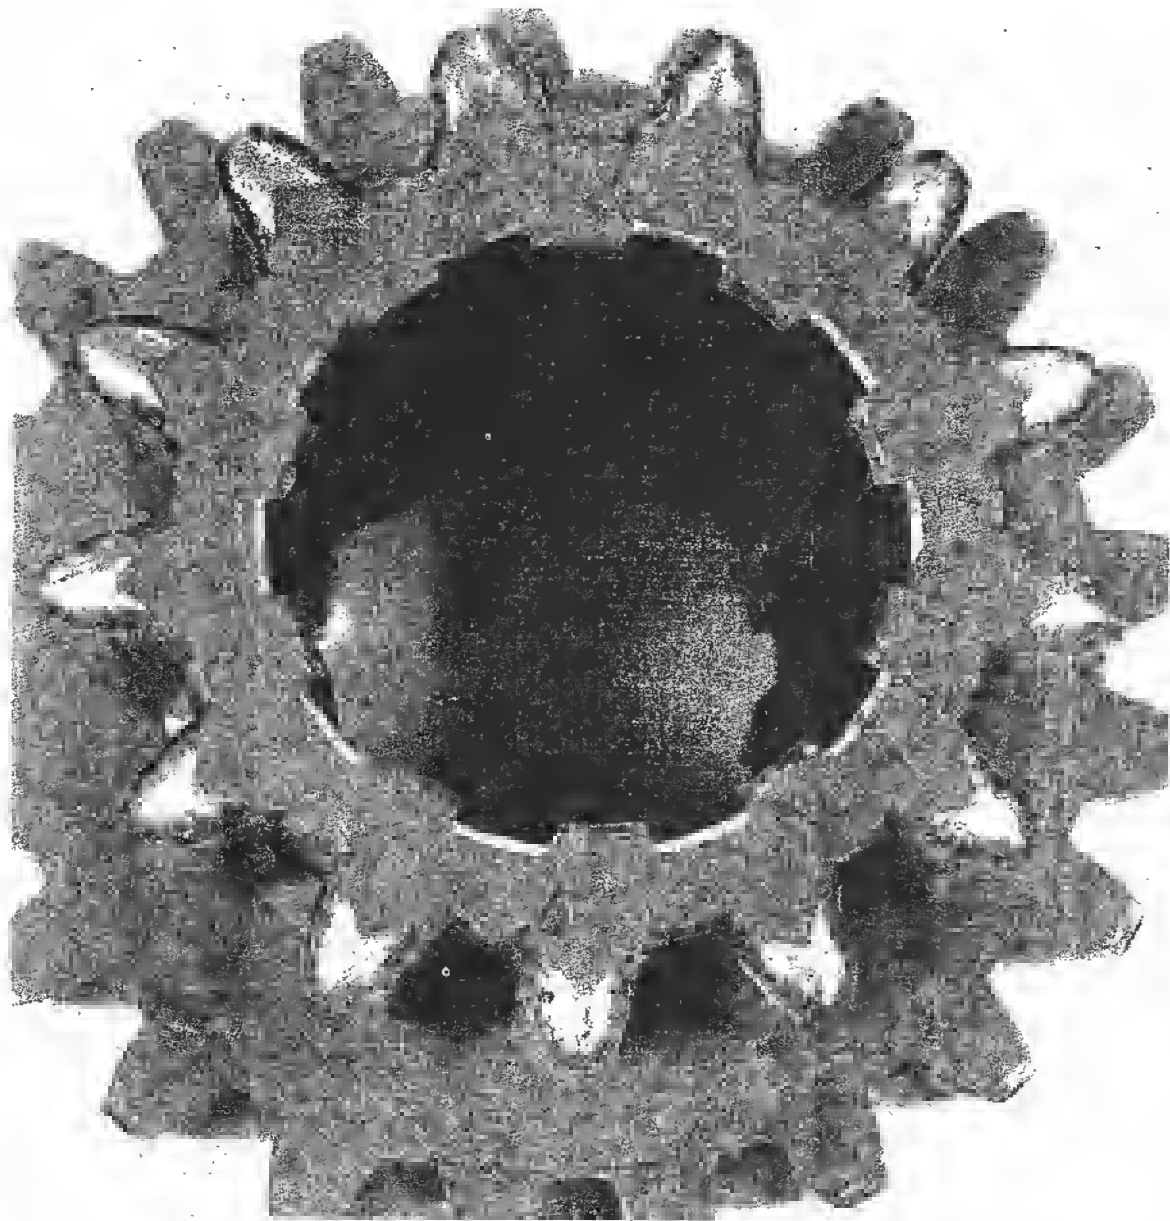
0702.5.2 - FIRST, SECOND, AND REVERSE IDLER DRIVE GEAR CLUSTER

each gear. It was machined all over, carburized and hardened. The gear was shot blasted and the top of the splines on the inside of the hub rough ground. The engaging ends of both gears of this cluster are chipped and battered. Photograph 0702.5.2. The 13 tooth gear has one side of the teeth pitted and worn by both mating gears. The other side of the teeth is burnished below the tool marks. The 21 tooth gear has one side of the teeth pitted and worn; the other side is burnished below the tool marks.

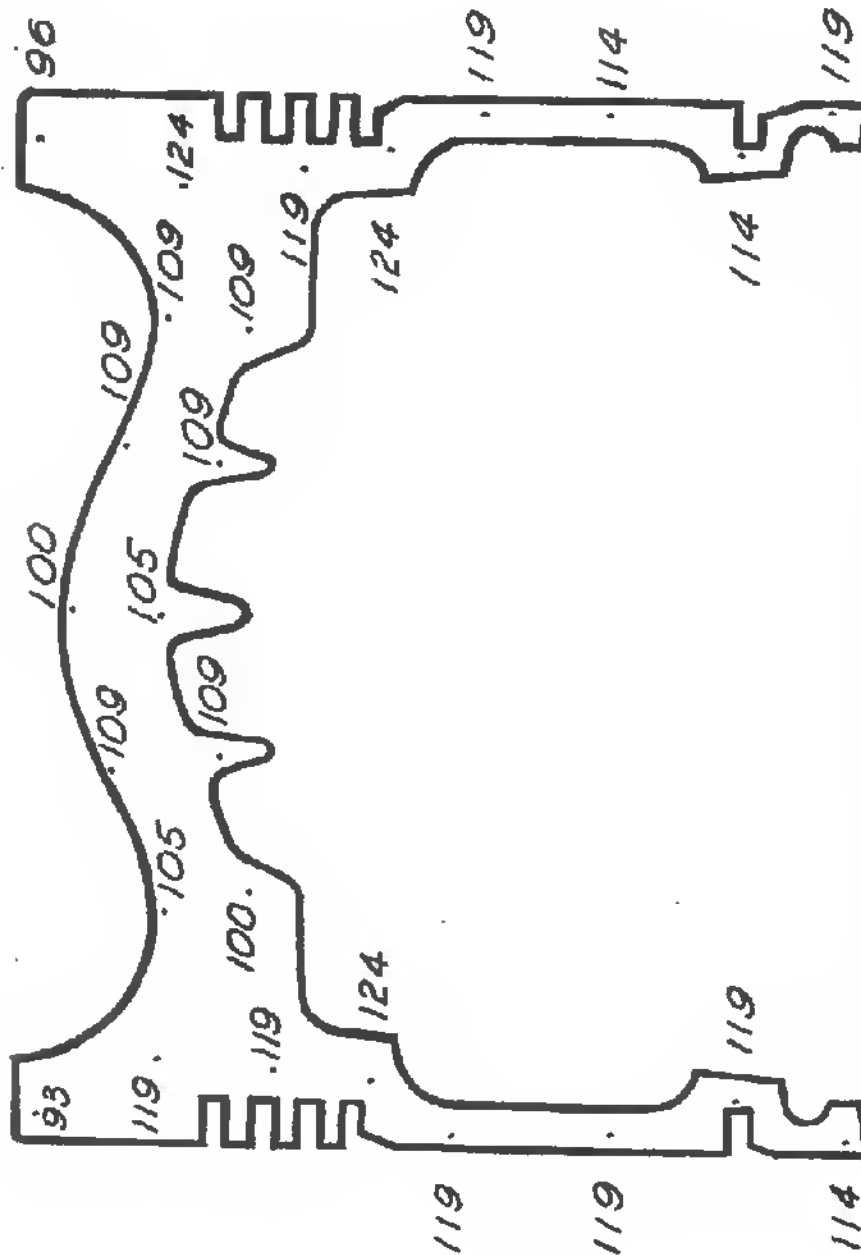
Surface hardness of the stud is Rockwell "C" 33-35. The threads are cut. The coating on the studs is iron oxide, probably from the heat treatment.

D. Manufacturing Method & Quality Forging - Satisfactory or fair quality. B.H.N. indicates Alcoa T6 condition - Solution heat treat and aged. Engine temperatures reduced hardness in crown of piston as shown in accompanying sketch.

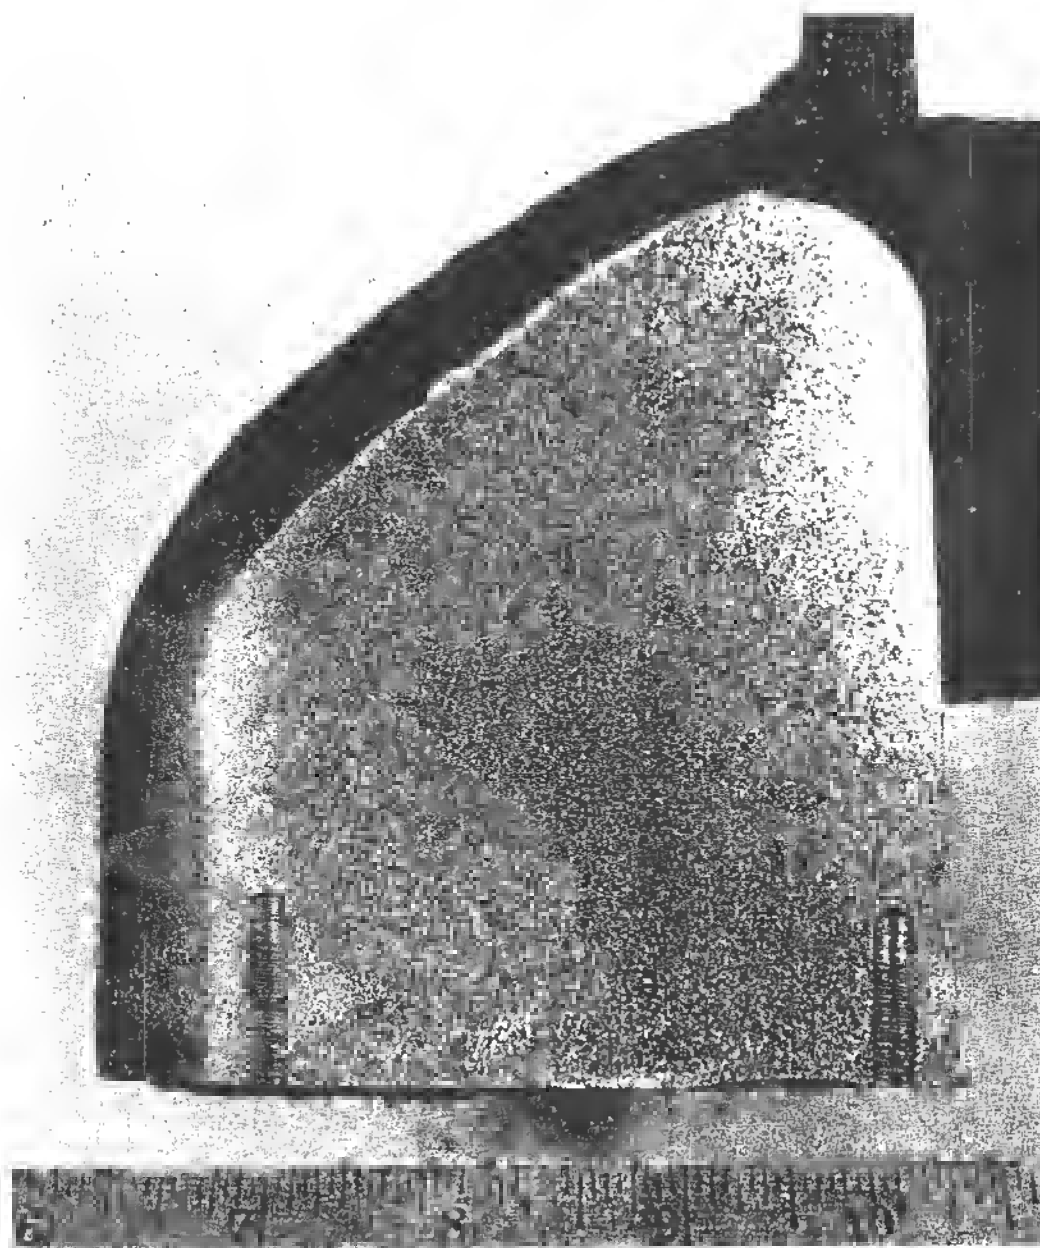
6417 - MACRO SECTION OF AIR CLEANER-TO-INTAKE MANIFOLD ELBOW

D. Manufacturing Method & Quality Sand casting - Poor
quality. B.H.N. values indicate as-cast condition.

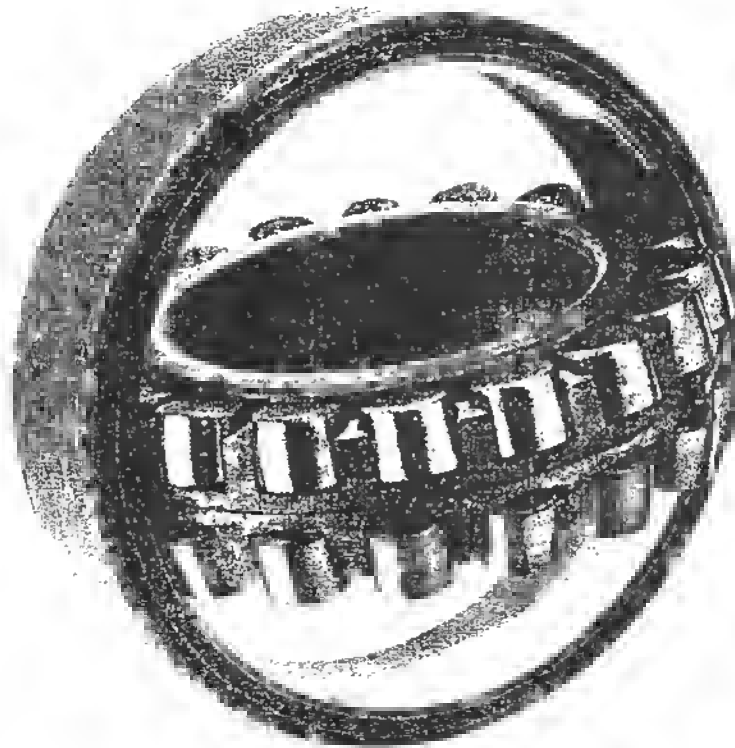
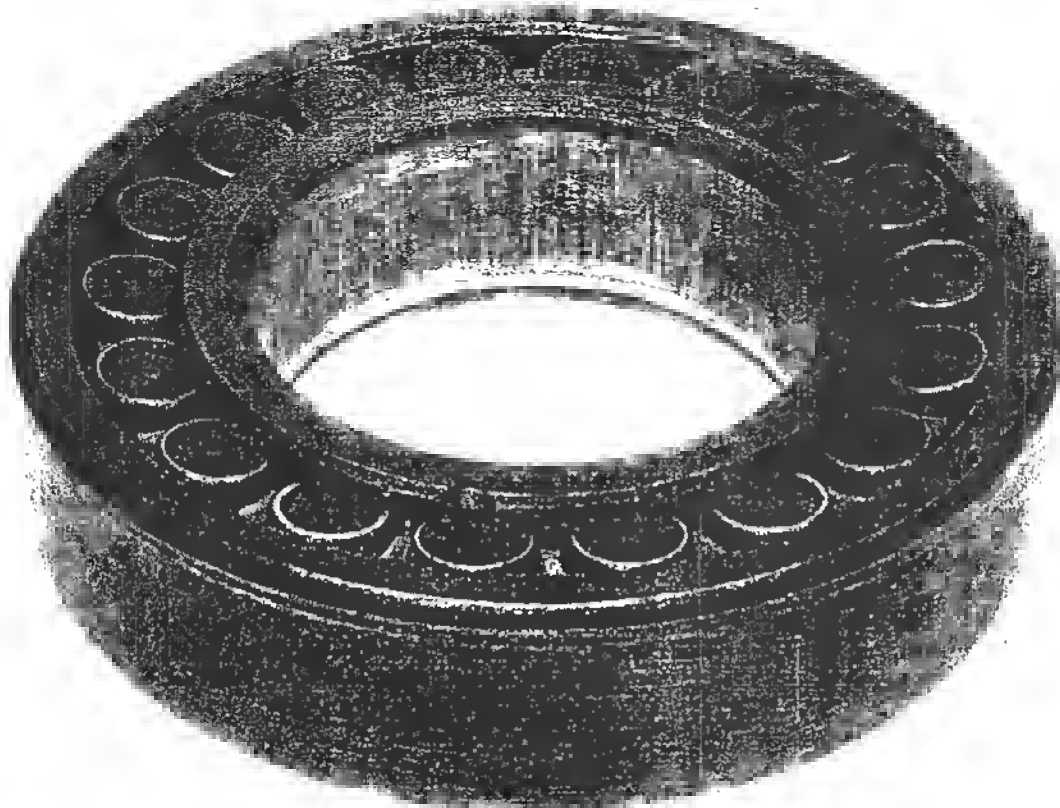
BEARING X-1 -

Inner Races	O.K.	<u>I.D.</u>	O.K.	<u>O.D.</u>
Outer Races	O.K.	except X-7(52 mu)	O.K.	except X-2 (35 mu)
Rollers			O.K.	
			O.K.

It should be noted that these bearings have been in service and could show some distortion. A certain amount of corrosion and wear is apparent.
